THE MIAMI CONSERVANCY BULLETIN

APRIL, 1921

The Successful Test of the Germantown Dam

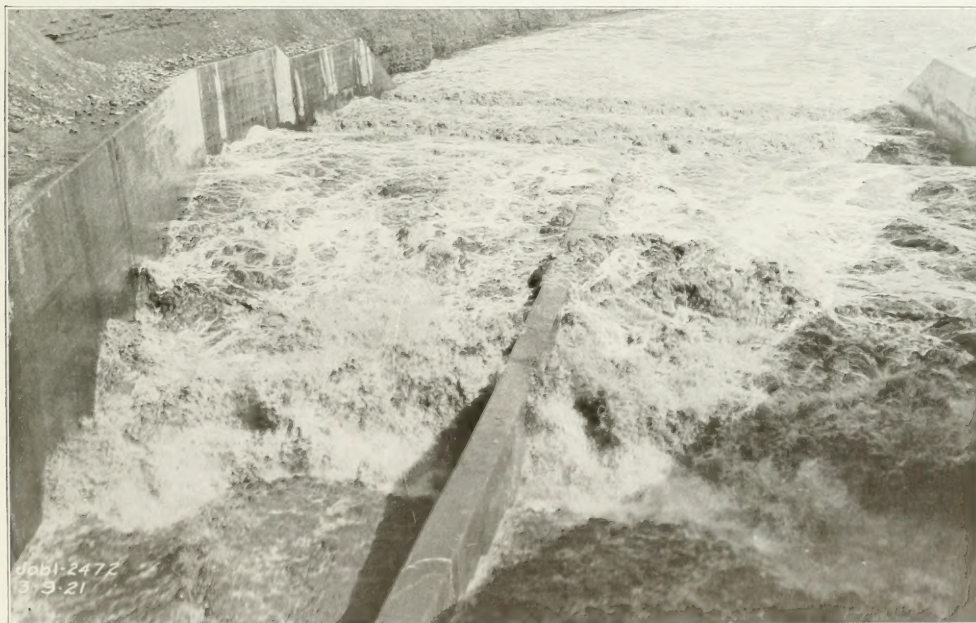
FIG. 290—GERMANTOWN CONDUIT OUTLET BASIN, FLOOD OF MARCH 9, 1921

Looking downstream from top of headwall over conduit mouth. The smooth dark water in the foreground is the rushing flow from the conduits as shown in Fig. 294. See also Figs. 287 and 292. The end of this smooth water is the beginning of the "hydraulic jump." The saw-toothed climbing of the water through the jump is shown clearly along the wall at the left as far as the angle in it. (Compare the wall top, which is level). The rise in water level was about $5\frac{1}{2}$ feet. The surface water flowed back down the incline toward the observer.

Fig. 292 is a corresponding view during the high water. Fig. 290 is a close-up looking downstream from the top of the wall over the outlets. Fig. 287 is similar to Fig. 292, but from a greater distance. All show very well the conditions with a flood flow through the conduits more than half that which would be produced by a storm like that of 1913. The kitten—now seen to have been a cub—is here as it were half grown, making "considerable splash," but powerless for harm—a young lion, but with its teeth drawn. A 1913 storm will bring the beast to full growth, but the same mechanism which pulled the young lion's teeth will pull the grown one's. The mechanism has been tried, and given ample evidence of its adequacy to the full task.

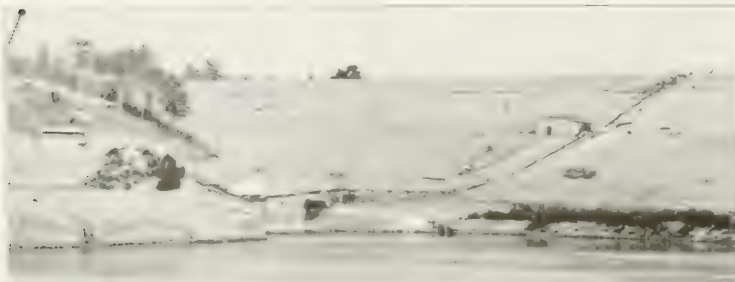
FIG. 297—PIPE LINE CLIMBING UPSTREAM SLOPE, GERMANTOWN DAM, JUNE 6, 1920.

The white iron "booster" pump is at the house half way up the slope; the "primary pump" in the house at the extreme left. The pipe line carries the earth (mixed with water) up the slope to build the dam at the summit. The "primary pump" drives the material as far as the "booster;" the latter "boosts" it on to the top.

mantown dam, on March 20, 1920, on the lower berm, about fifty feet above the valley floor, to act as "booster" to the "primary pump," of similar capacity, which was in the main pump house, on the lower valley slope, 40 feet below the booster. The dam summit was 47 feet above the booster, and the "sump" or cistern which fed the primary pump suction was 7 feet below the primary pump. This layout is shown in Figs. 297 and 298, the booster being in the lower right-hand corner of Fig. 298, and the primary being in the pump house in the upper left. In Fig. 297 the booster is at the upper pump house (at the right), and the primary pump house is at the left; this figure showing plainly also the pipe line connecting the two and proceeding on to the dam summit.

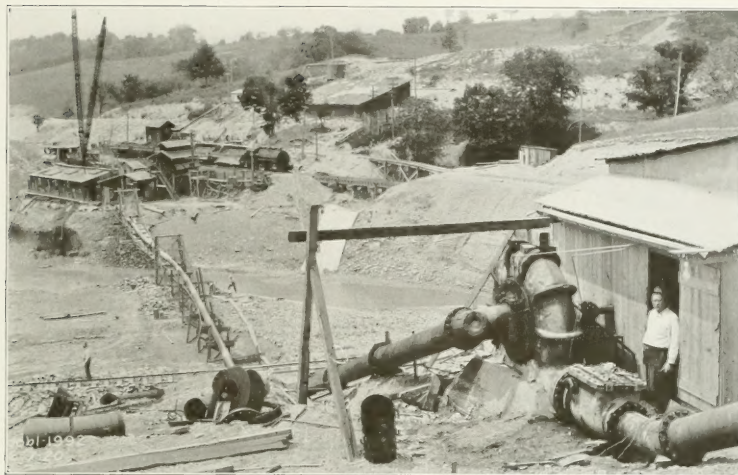
FIG. 298—WHITE IRON BOOSTER PUMP, GERMANTOWN DAM, JUNE 1, 1920

This is the pump half way up the slope in Fig. 297. It is driven by a 350 horse power electric motor in the house. The mixed earth and water coming up the pipe at the slope are sucked in at the center of the pump shell and driven out again up the pipe at the right to the dam top. Revolving paddles within the shell do the work, whirling the material from the pump shell into the pipe at the bottom like a stone from a sling. This pump drove 380,000 wagon loads of earth to the top of the dam.

A little more detail on this point may be interesting. Considering the face of the pump in Fig. 298 under the analogy of a clockface, at "six o'clock" the original thickness was 5¾ inches, the final 3½ inches; at eight o'clock, the original thickness was 5 inches, the final thickness 4 inches; while at 10 o'clock and 12 o'clock, where the original thickness was 4½ and 4¼ inches respectively, the wear was so little as to make its measurement uncertain, considering the irregularities of the metal surface. The concentration of the wear at the bottom and lower left quadrant is notable, and if shown by later tests to be normal, may well be taken account of in the design.

The ribs cast on the new pumps, which appear prominently in Fig. 298 are an important feature. The pump shells wear thin and fail eventually, cracking along the midline at the outside rim. The ribs prevent this cracking, and will enable the shells to wear till actual holes appear at the rim. Even then,
